4 February 2021

Spring Repair Project

Vancouver Electric Vehicle Association

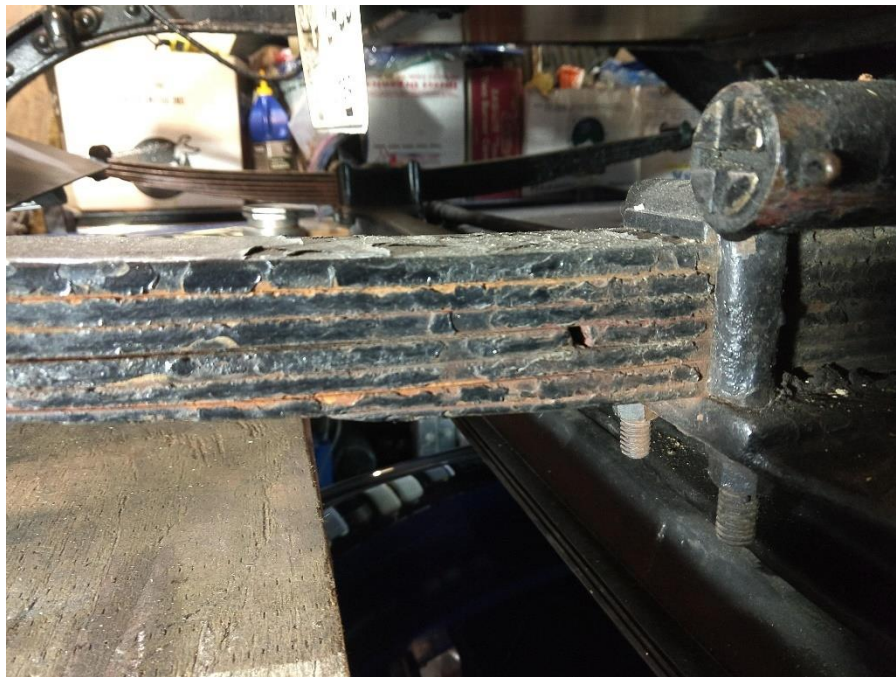
The front left spring was originally thought to have two of the seven leaves broken. One of the breaks can be seen in the figure. A quick measurement found that the front left side of the car was 9/16" lower on the left than the right, and a little less than that at the rear.

Figure 1: Broken Leaf, Front left Spring

The broken spring was taken to a local spring repair shop for repair. Luckily, the Detroit springs are made from relatively common 1.75" spring stock, and replacement leaves could be made easily. It turned out that three of the seven leaves in the front left spring were broken. After making new leaves, the spring repair shop re-curved the original and new leaves for the left side to match the righthand spring. Finally, the springs were assembled with powdered graphite between the leaves for lubrication as prescribed in drawing 32102 – downloaded with thanks to the electricvehiclemuseum.org and Galen Handy.

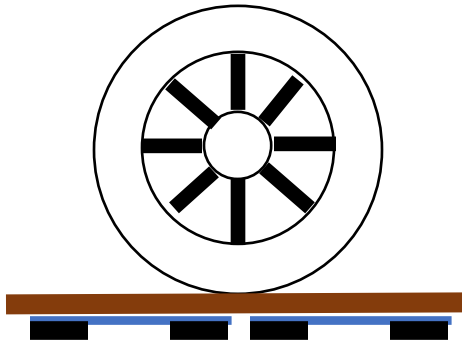
Figure 2: Weighing a Detroit With Bathroom Scales

As the weights show, even though the side-to-side weights were within 33 lb., the front left and rear right weights were significantly higher – indicating a twist in the frame.

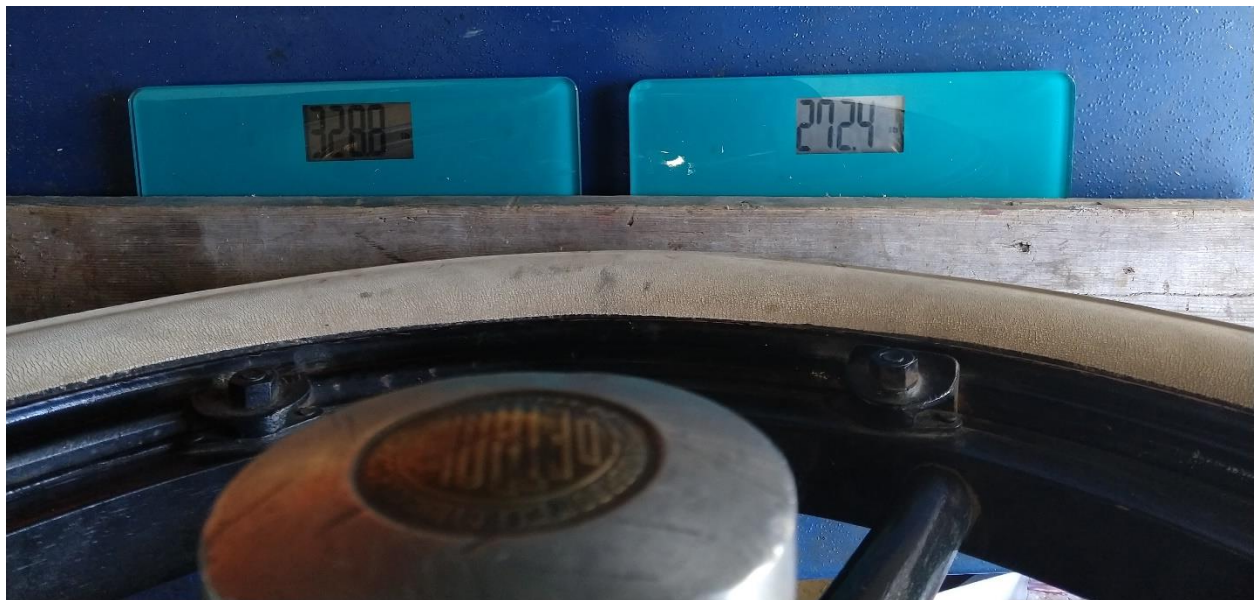
Figure 3: Front Left Wheel on the Scales

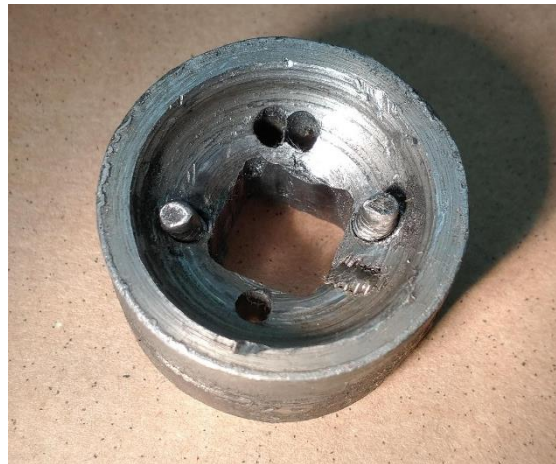
Figure 4: Homemade Shackle Nut Tool

Special tools are the bane of every home mechanic, and even in the time of the Detroit Electric special tools were created to annoy. In this case, the dome nuts for the shackle bolts required a special tool to loosen them. The pictured tool is homemade on the trusty Craigslist lathe that has helped on so many previous projects. The tool is used with an electric impact gun to loosen and tighten the shackle bolt nuts. After reinstallation, the ends of the shackle bolts are peened to lock the nuts in place, exactly as it was originally.

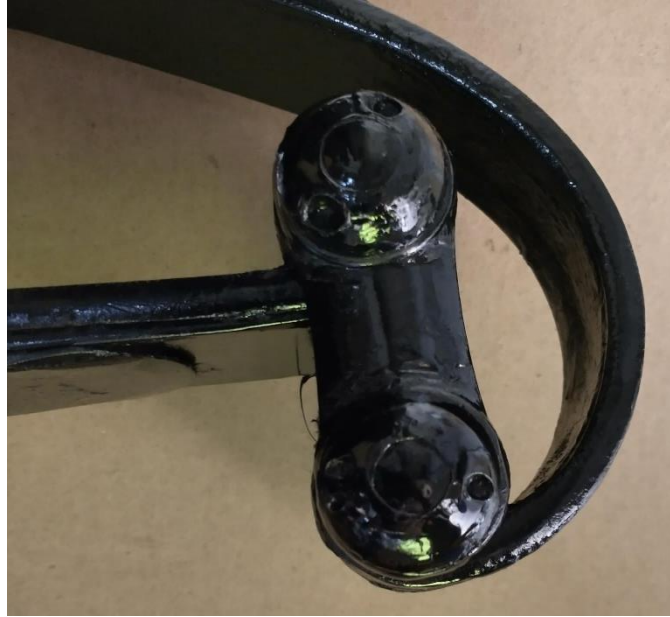
Figure 5: Domed Shackle Nuts

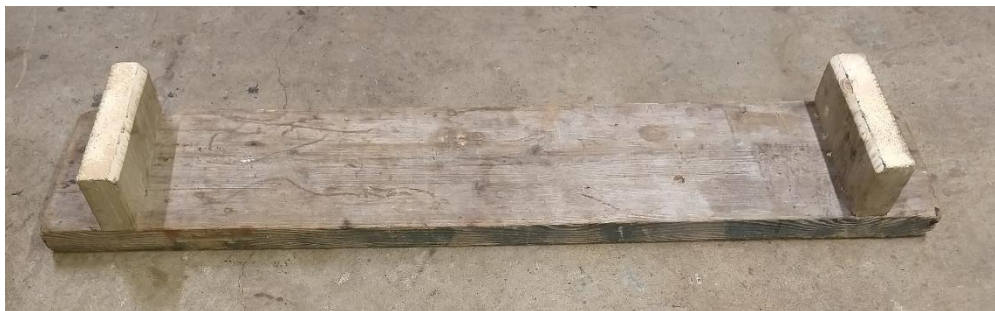
Figure 6: Cradle for Rear Frame

To lift the rear of the car, a wooden cradle was required to support the frame, while avoiding the rear battery box.

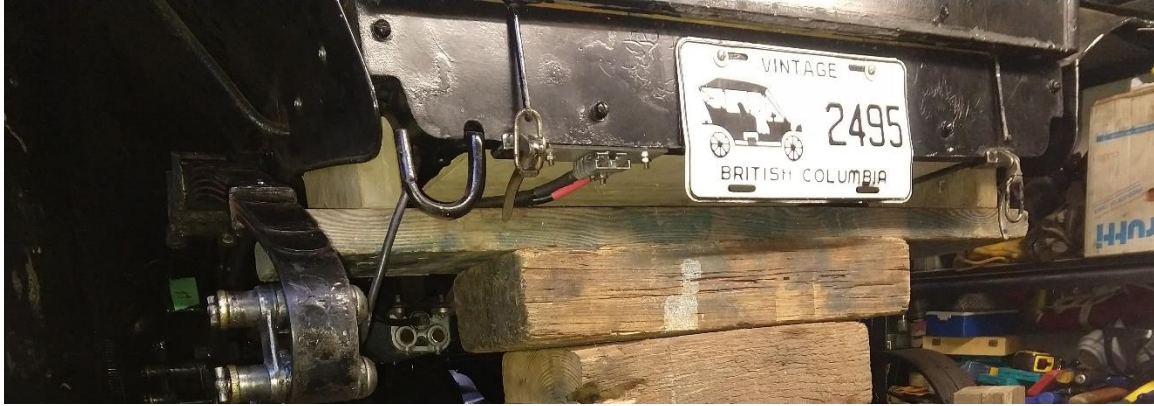
Figure 7: Rear Frame Cradle Supporting Car

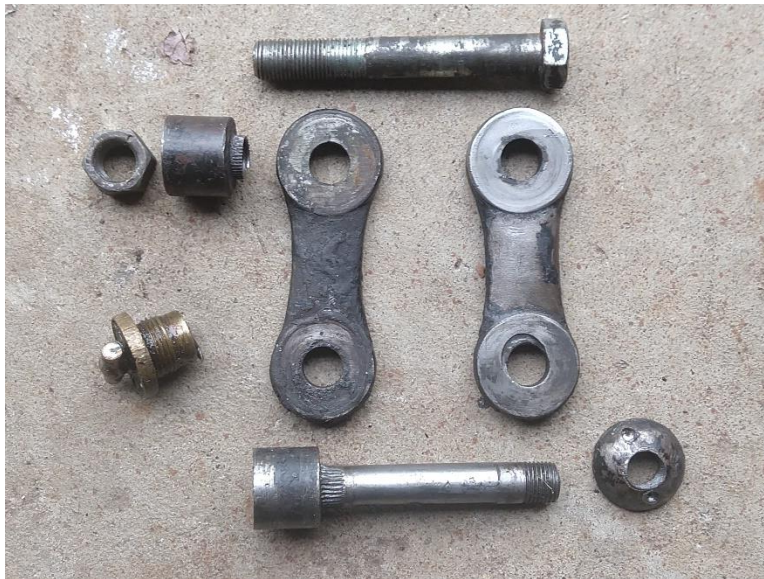
Coincidentally, or perhaps not so coincidentally, the shackle on the front, left spring was damaged, and had been previously repaired.

The shackles on these cars consists of two shackle links and two shackle bolts. The shackle bolts have a holder for a grease cup. The top shackle bolt had broken off and had been replaced with an ordinary bolt. Thankfully, the grease cup holder for the broken bolt had been left in place, so the repair was much easier.

Figure 8: Spring Shackle Components with Broken Shackle Bolt

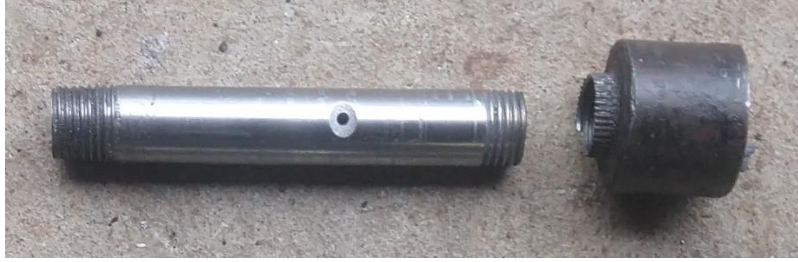
Figure 9: New Shank to Repair Shackle Bolt

To repair the broken shackle bolt, a new bolt shank was made. The inside of the existing grease cup holder had been threaded as part of the previous repair, so the new shank only needed to be threaded to match the grease cup holder.

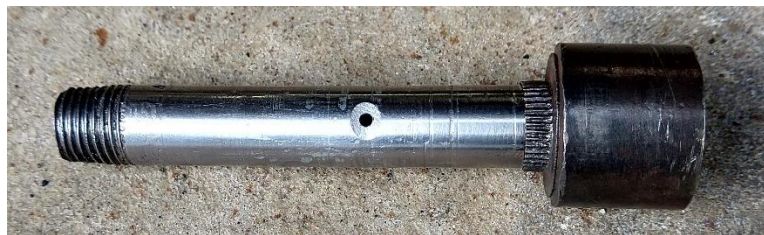
Figure 10: Repaired Shackle Bolt

In addition, a grease passage was drilled through the center of the shank, and another hole was drilled to allow the grease to escape and lubricate the bronze bushing through which the bolt passed. After the new shank and original grease cup holder were threaded together, the grease cup holder was welded to the shank from the inside of the grease cup and the bolt was as good as new.

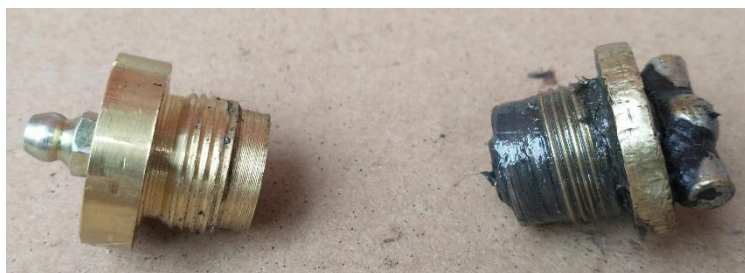
Figure 11: Replacement and Original Grease Cups

The original grease cup was also missing, so it was replaced with a threaded brass plug with a standard Zerk grease fitting installed. Coincidentally, the original grease cups were also made by Zerk. Turning the "T" handle on the original grease cup turns a screw that moves a plunger that forces out the grease from inside the hollow cup. The replacement grease cups were also made on the well-used Craigslist lathe – annoyingly, the grease cup's 3/4"-18 thread does not match a fine 3/4"-16 thread, so replacement grease cups could not be made from a 3/4" bolt.

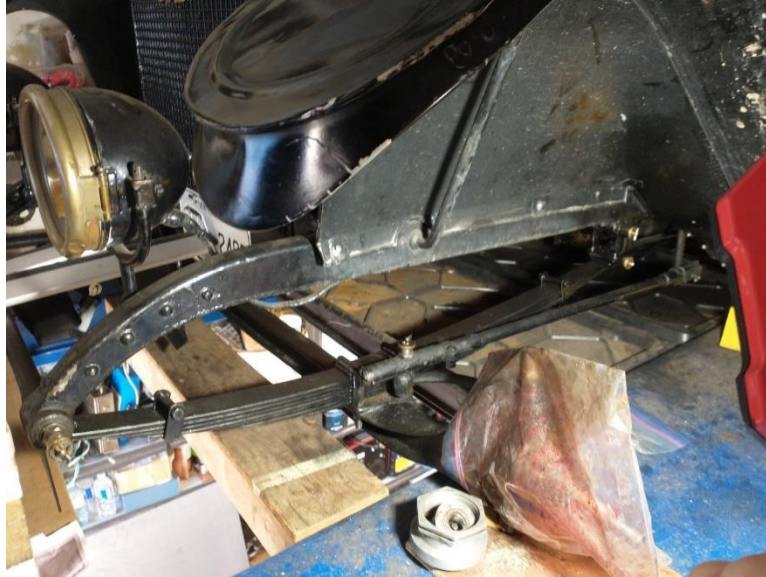
Figure 12: Repaired Front Spring

After the springs and shackles had been cleaned and repainted, they were re-installed in the car. At first it was disappointing to measure that the car still leaned a small amount to the left. However, swapping the rear springs from side-to-side resulted in the rear of the car sitting level, and the front left down approximately 1/8". It is anticipated that this inequality will lessen over time as the twist in the frame relaxes.

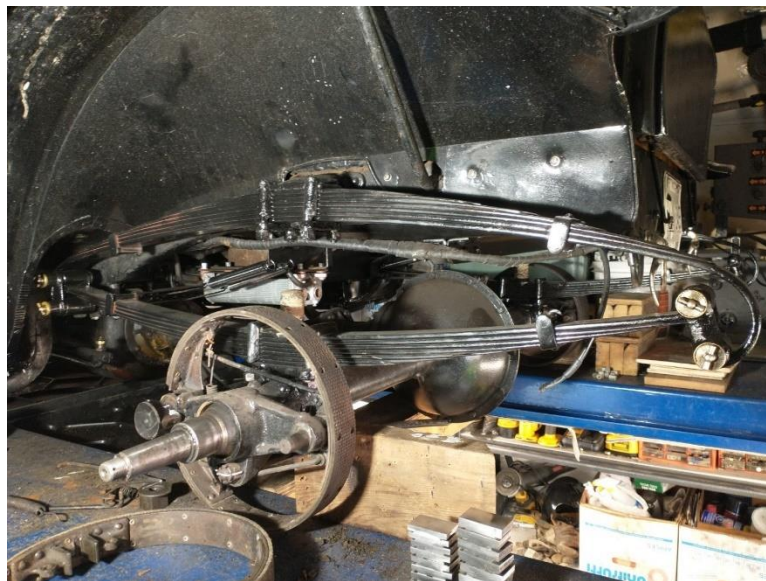
Figure 13: Rear Spring
